**HAKKO 850D HOT AIR STATION
CHINESE KNOCK-OFF ATTEN 850D**

Reverse-Engineered By: **Guru**
<https://gurudumps.otenko.com>

Date: 21/06/2026 11:18 PM Sheet: 1/1 REV: A

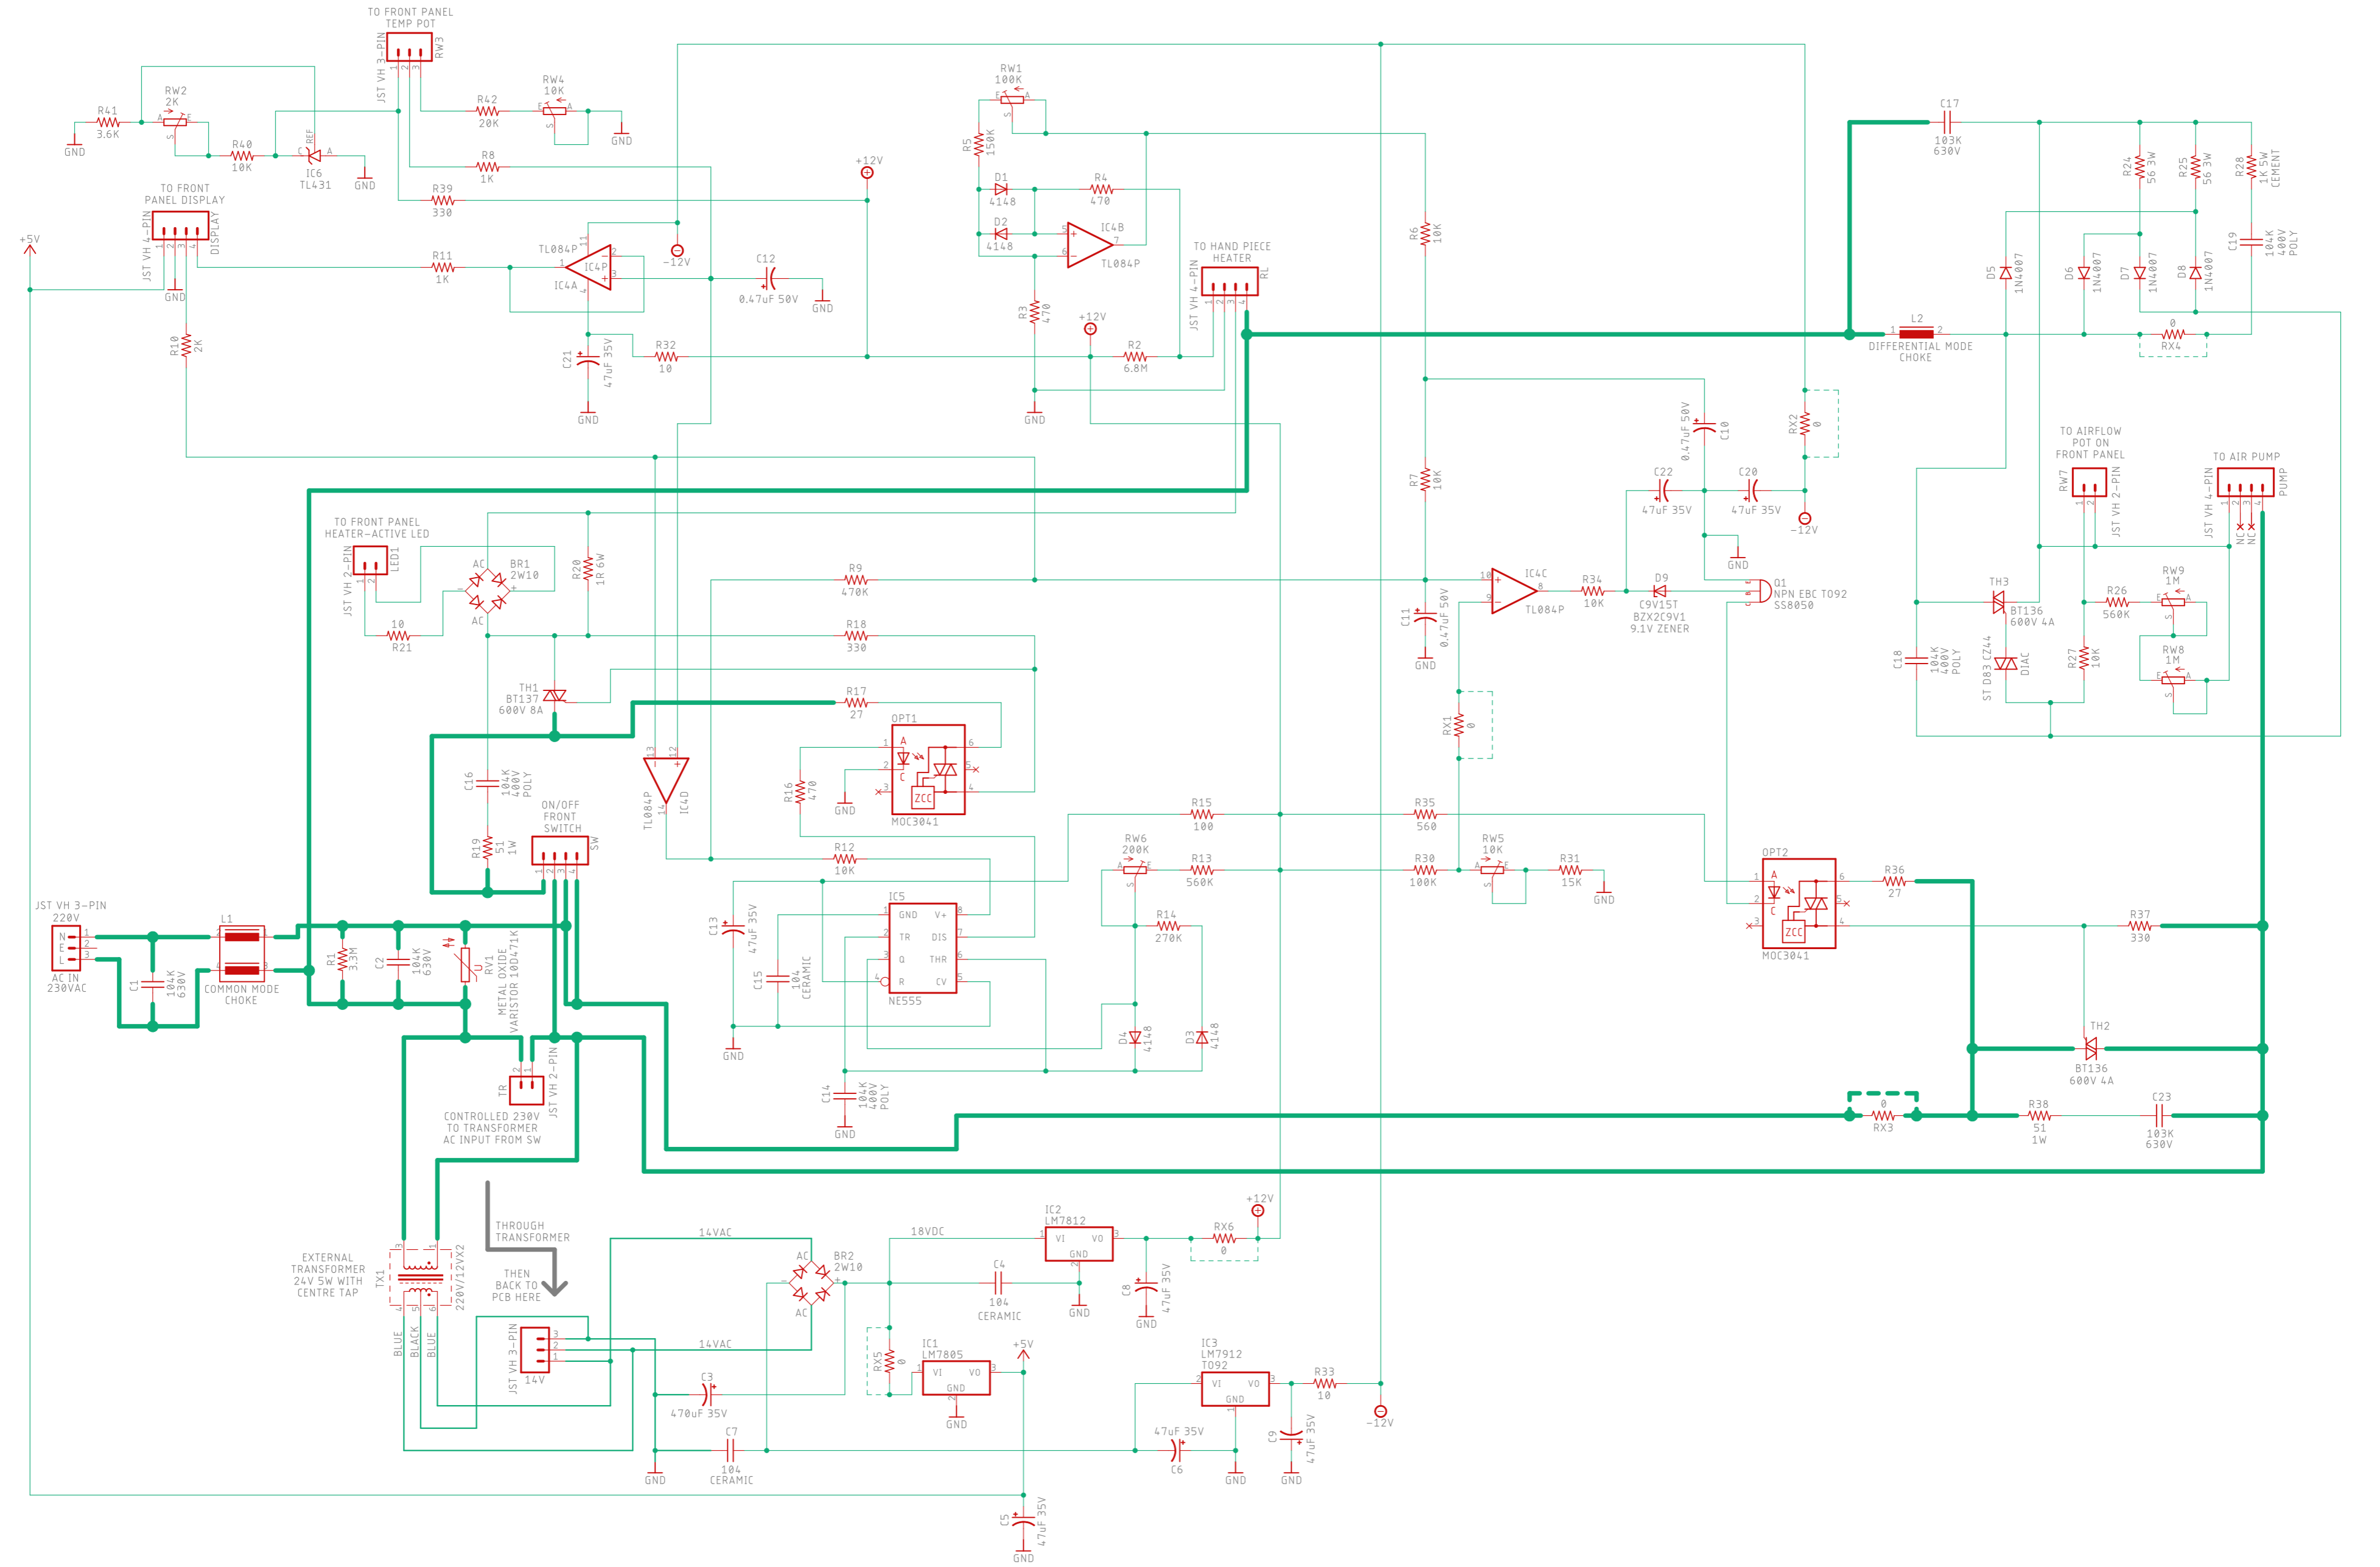
FAULT / REPAIR HISTORY	NOTES
1. BAD BT136 @ TH2 PINS 1+2 SHORTED AND MELTED EXTERNAL TRANSFORMER. REPLACED TH2 WITH BT139 AND REPLACED TRANSFORMER WITH EQUIVALENT CHINESE 24V CENTER-TAPPED 5W TRANSFORMER FROM ALIEXPRESS.	This is an Atten 850D which is probably a straight rip of Hakko 850D but possibly using more common parts.
2.	Single-sided PCB using some zero ohm resistors to jump over traces. Dotted lines are there to keep the signal names the same.
