# SEIBU HB-41

Reverse-Engineered By:

GURU  
<https://gurudumps.blogspot.com>

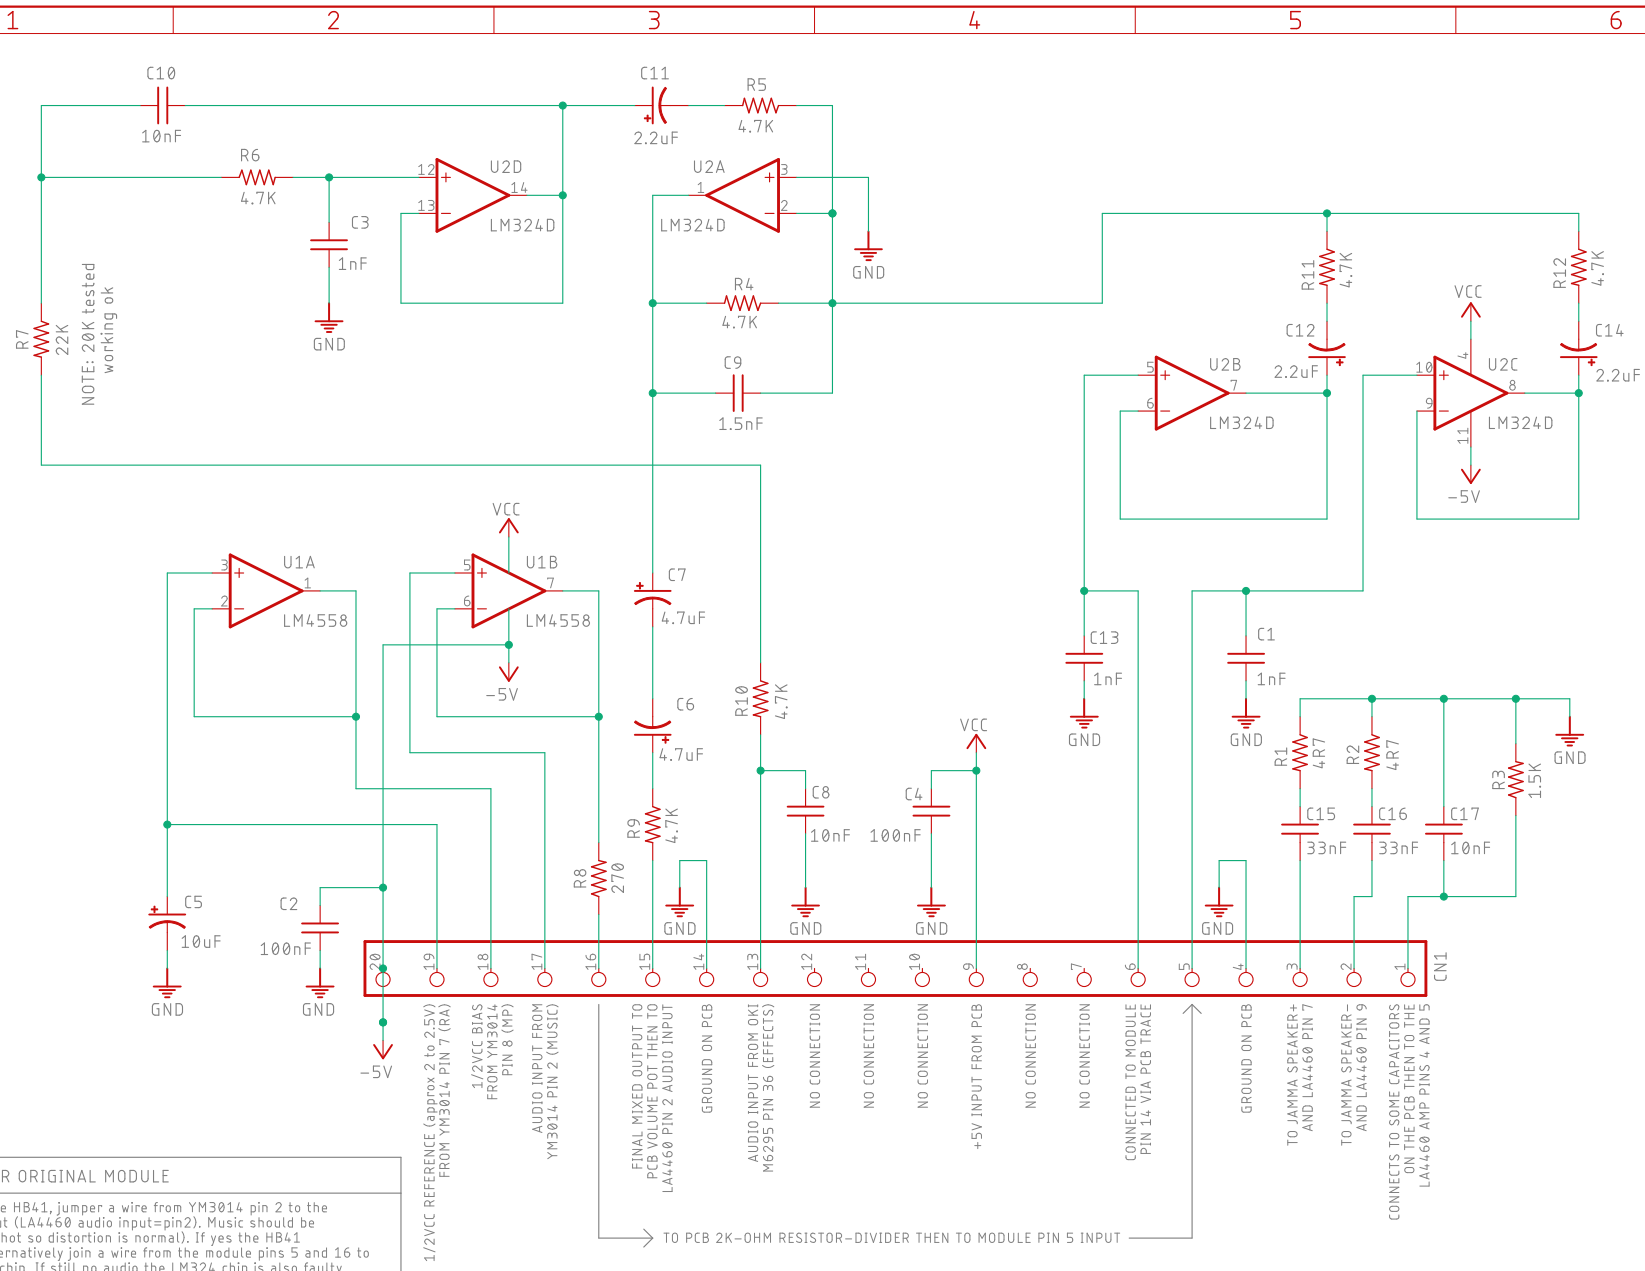
- To test-bypass the HB41, jumper a wire from YM3014 pin 2 to the main power AMP input (LA4460 audio input=pin2). Music should be audible (level is too hot so distortion is normal). If yes the HB41 module is faulty. Alternatively join a wire from the module pins 5 and 16 to bypass the LM4558 chip. If still no audio the LM324 chip is also faulty.

- If game music is missing check the YM3014 on the PCB pin 2 using an oscilloscope. If no activity the YM3014 or other Yamaha sound chip(s) are faulty. If there is activity when music is playing the HB41 module LM4558 chip is faulty. Check with the bypass test. The chip can be removed using a knife with break-off segments. SLOWLY scrape away at the black coating and uncover the LM4558 chip. When the knife becomes blunt break off a segment and continue until the chip is completely visible. Remove it using hot air then replace it with a new chip. If the module traces 'disappear' you must rebuild them using small wires.

- The HB41 contains several tantalum capacitors. They are only powered by 5V so are rare to fail but still possible. Tantalum caps can be uncovered and replaced using the same method as replacing the LM4558. Ensure polarity is correct otherwise the tantalum capacitor will blow up (sparks/fire etc).

- NOTES**
1. All tantalum capacitors are minimum 10V. 16V or 20V is ok.
  2. Module pinout based on SEIBU/TAD Blood Bros PCB.
  3. Rev 1B - Changed tantalum cap footprint to match original module so parts can be salvaged from the original module.
  4. Rev 1B - Changed footprint and value of some resistors and capacitors to match original module.
